IMPACT & CYCLING PERFORMANCE TEST REPORT

NCTL-110-19383-3

PRODUCT TYPE: FIXED SKYLIGHT

SERIES/ MODEL: "SKYFLOOR™ WALKABLE SKYLIGHT - FA-TB 4X4"

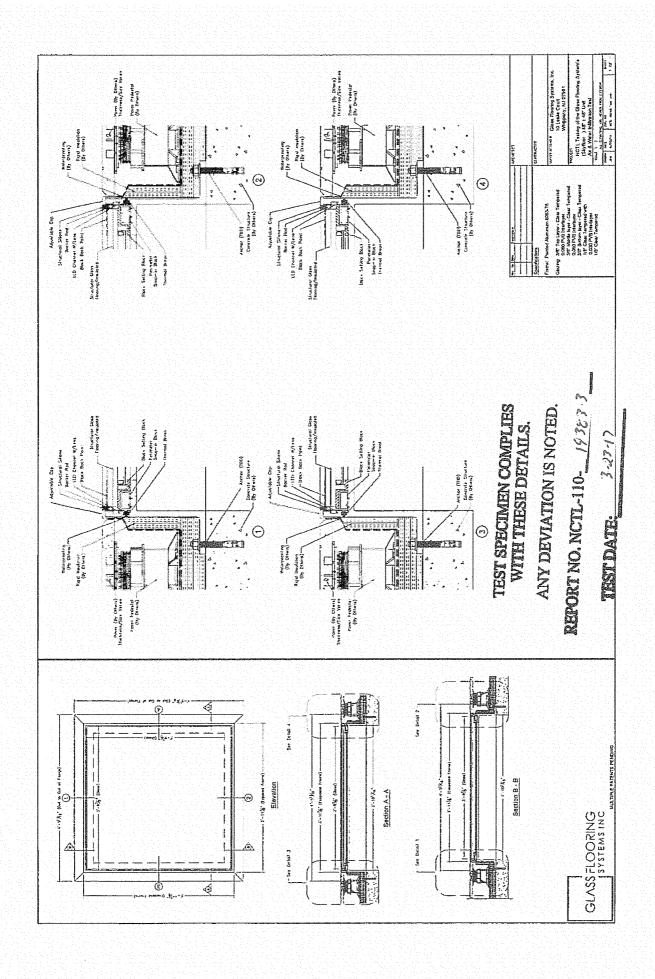
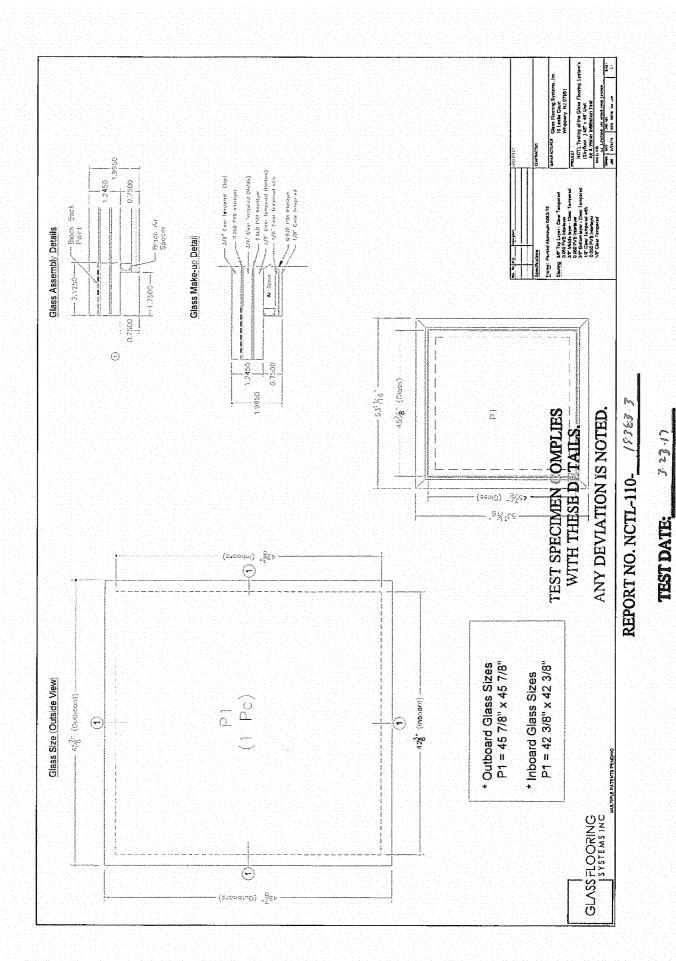
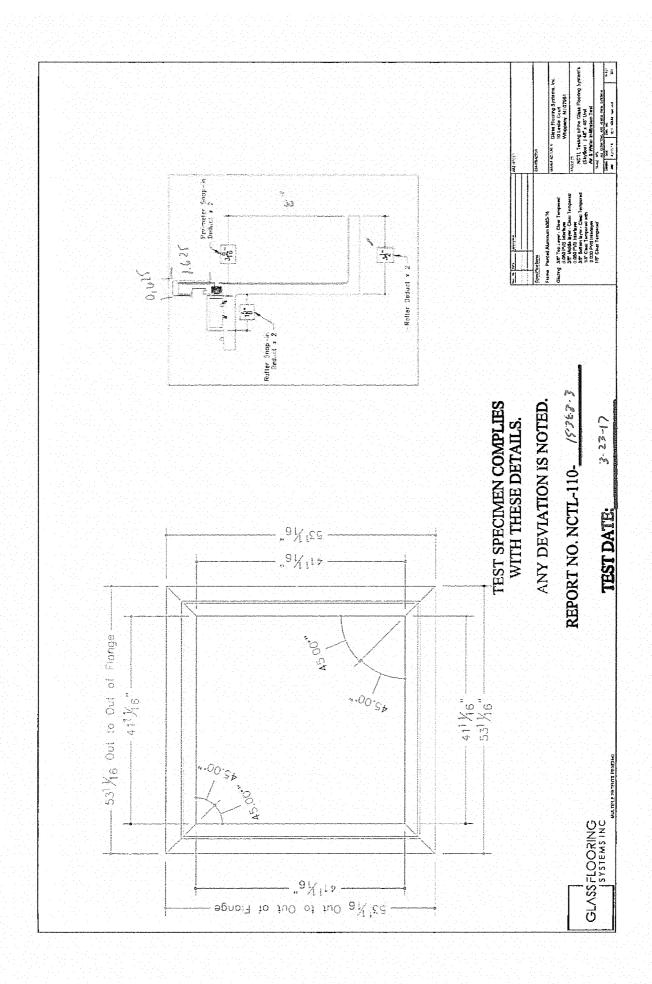
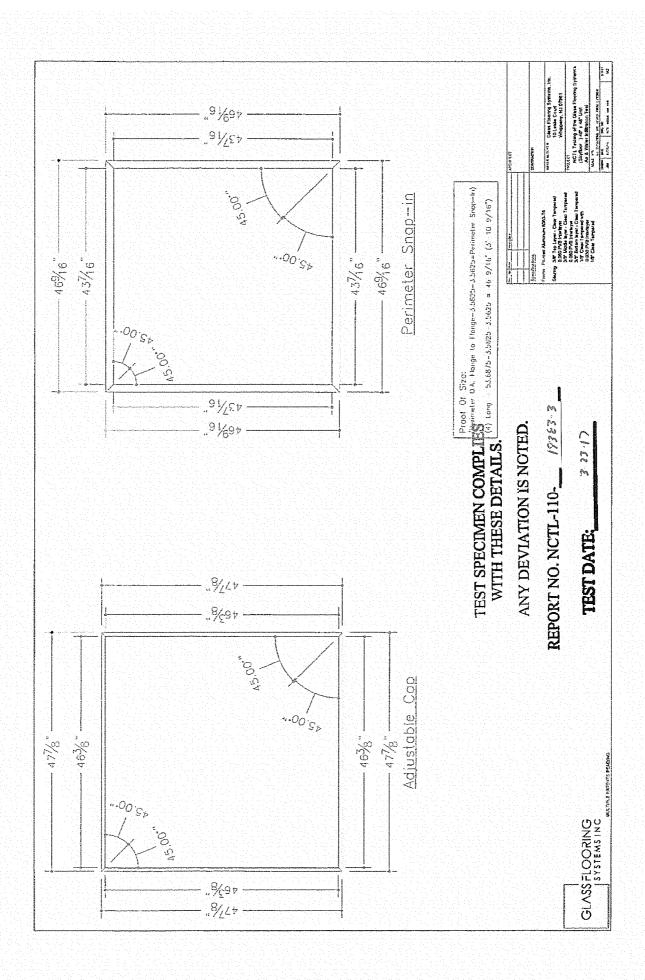
DRAWINGS

Component Drawings, with Applicable Part Numbers, Manufacturing and Modeling Details, were reviewed (as submitted) for Product Verification (Reference: NCTL-110-19383-3)
